AD NUMBER	
AD357977	
CLASSIFICATION CHANGES	
TO:	UNCLASSIFIED
FROM:	SECRET
LIMITATION CHANGES	
TO: Approved for public release; distribution is unlimited. Document partially illegible.	
FROM: Distribution authorized to U.S. Gov't. agencies only; Administrative/Operational Use; 1953. Other requests shall be referred to Atomic Energy Commission, Washington, DC. Document partially illegible.	
AUTHORITY	
AEC ltr 16 Jun 1980 ; AEC ltr 16 Jun 1980

The purpose of Signal Corps participation in Project 3.20 was to determine the amounts of thermal flux (cal) and peak overpressure (psi) required to cause severe, moderate, light, and negligible damage to selected signal communications-electronics items of equipment and material for which inadequate or no data existed. Knowing these factors it is believed that responsible signal officers can better plan their tactical communications systems and take passive protective measures to reduce damage and losses to acceptable minimums. These data will also be used to improve design of equipment and material.

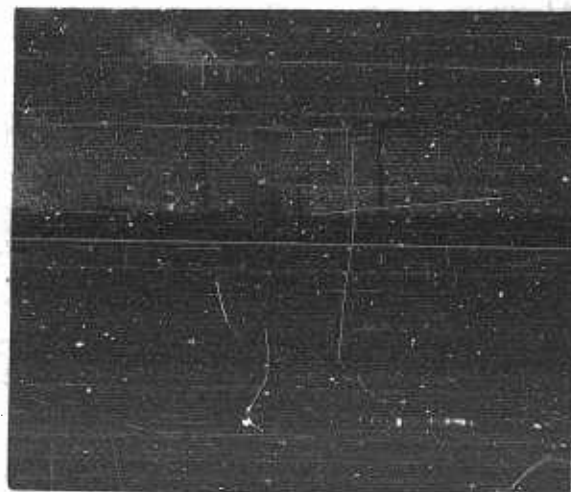
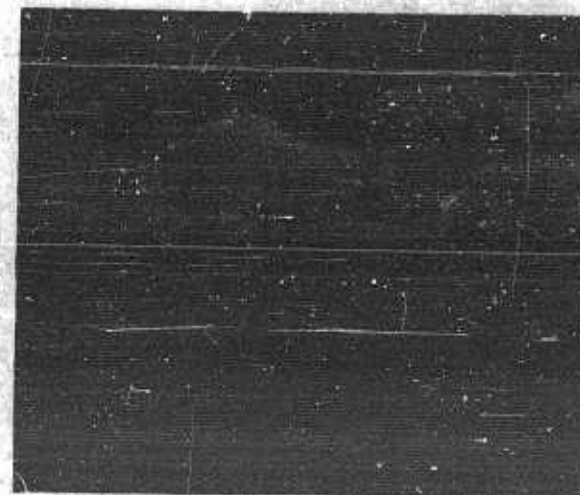
b. RESULTS: The five pair rubber-covered cable and the spiral four cable received no thermal or blast damage. The WD-1/TT field wire received severe thermal and blast damage (3400 ft, 50.0 cal, 9.6 psi).

Fig. 3.53 Shot 9, Test Group 25,
Surface Laid Wire and Cable Along
Transverse Pole Line. Photos Taken
from Center of Lays Looking West.
(Top-before, Bottom-after) 3400 ft,
50 cal, 9.6 psi.

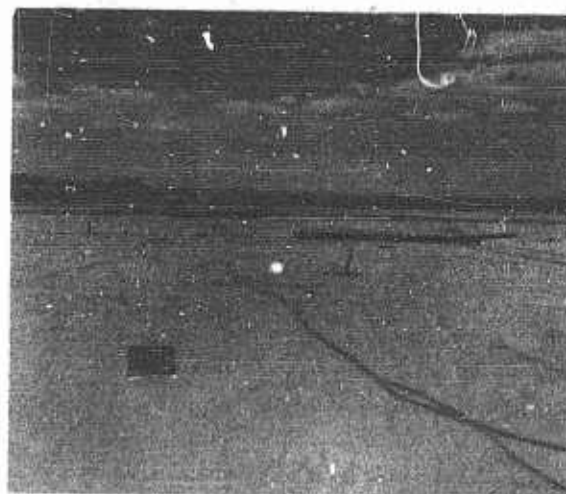
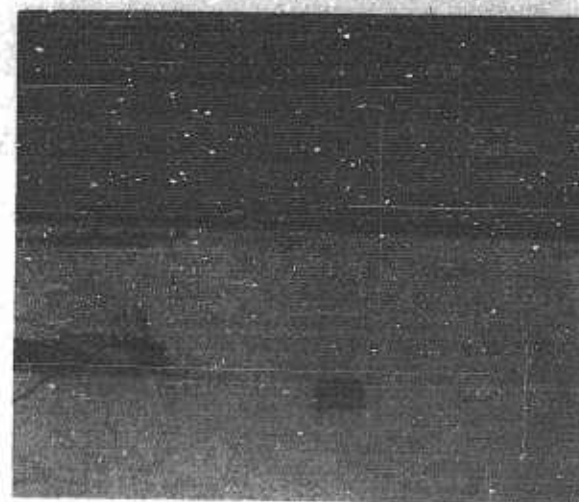
Fig. 3.54 Shot 9, Test Group 25,
Surface Laid Wire and Cable Along
Transverse Pole Line. Photos Taken
from Center of Lays Looking East.
(Top-before, Bottom-after) 3400 ft,
50 cal, 9.6 psi.

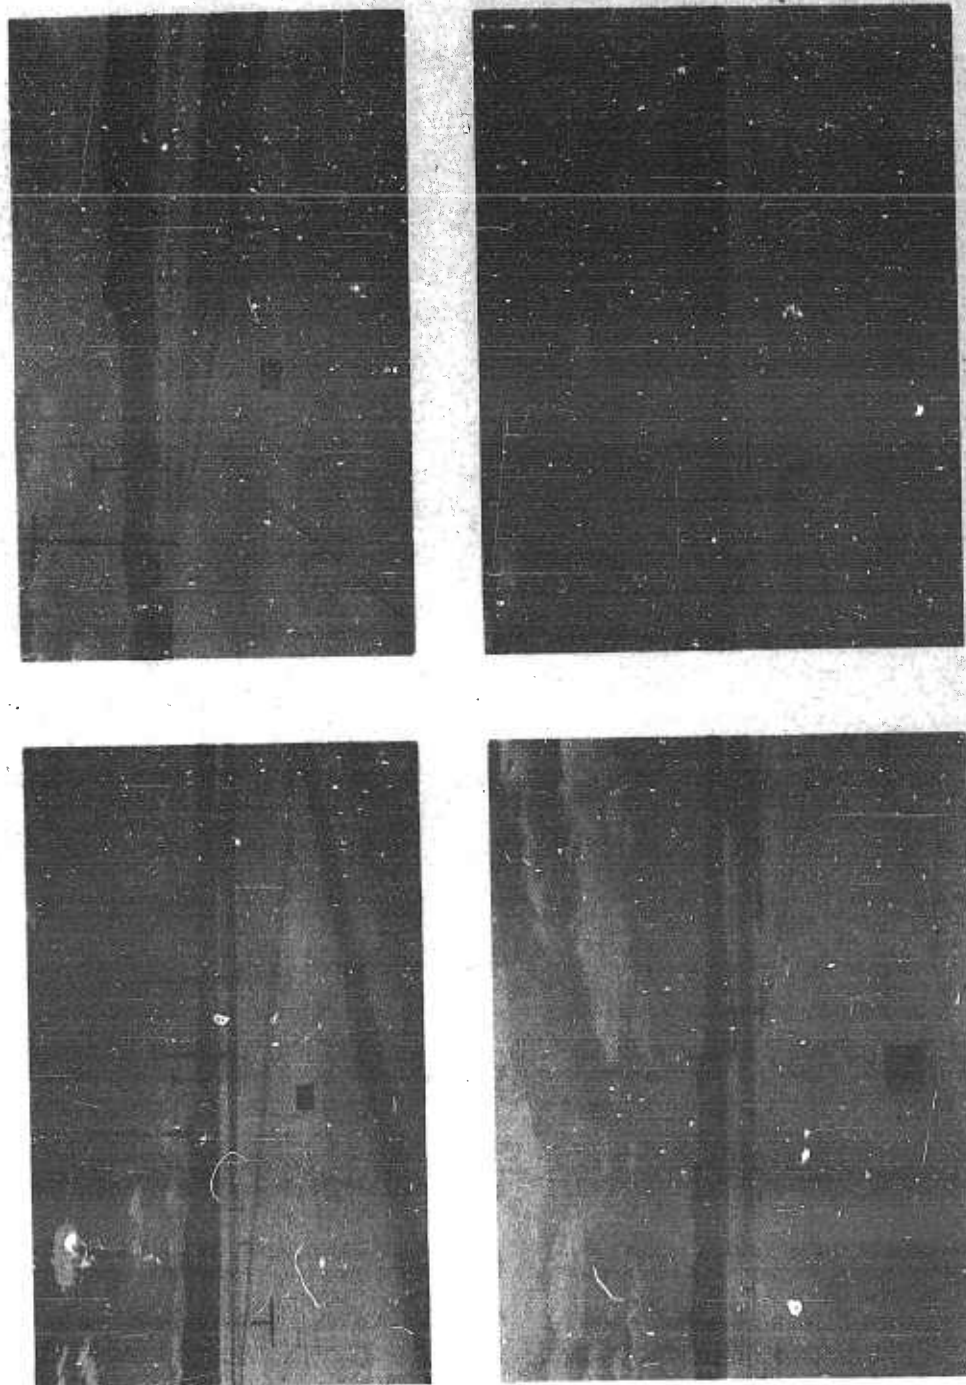
b. RESULTS: The five pair rubber covered cable and the spiral four cable received no thermal or blast damage. The WD-1/TT field wire received severe blast and thermal damage (4425 ft, 35 cal, 7.0 psi).

Fig. 3.55 Shot 9, Test Group 28, Surface Laid Wire and Cable along Transverse Pole Line. Photos Taken from Center of Lays Facing West. (Top left-before, Bottom left-after) Photos Taken from Center of Lays Facing East. (Top right-before, Bottom right-after) 4425 ft, 35 cal, 7 psi.

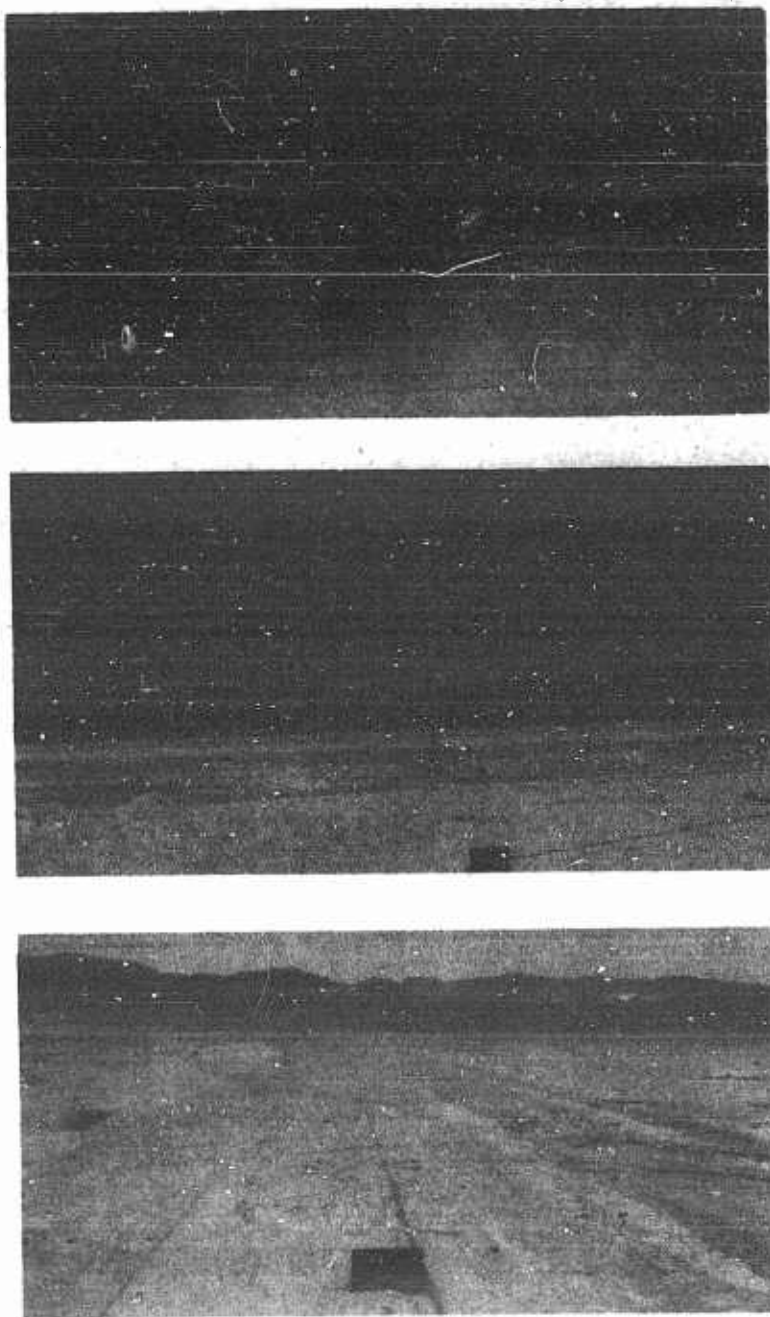
b. RESULTS: Test Groups 3A-6A were severely damaged. Test Group 7A received light blast damage. Test Groups 8A-9A received negligible damage in Shot 10. A damage summary for these test groups is shown in Table 3.8.

Fig. 3.59 Shots 9 and 10, Test Groups 5 and 5A, Separate Poles. (Top-before 9, Center-after 9, Bottom-after 10) (In Bottom View Note the Foxhole on Left Hand Side of Photo - Test Group 5A was Located about 500 ft forward and 50 ft to the Left of this Foxhole. The Pole was Disintegrated.)

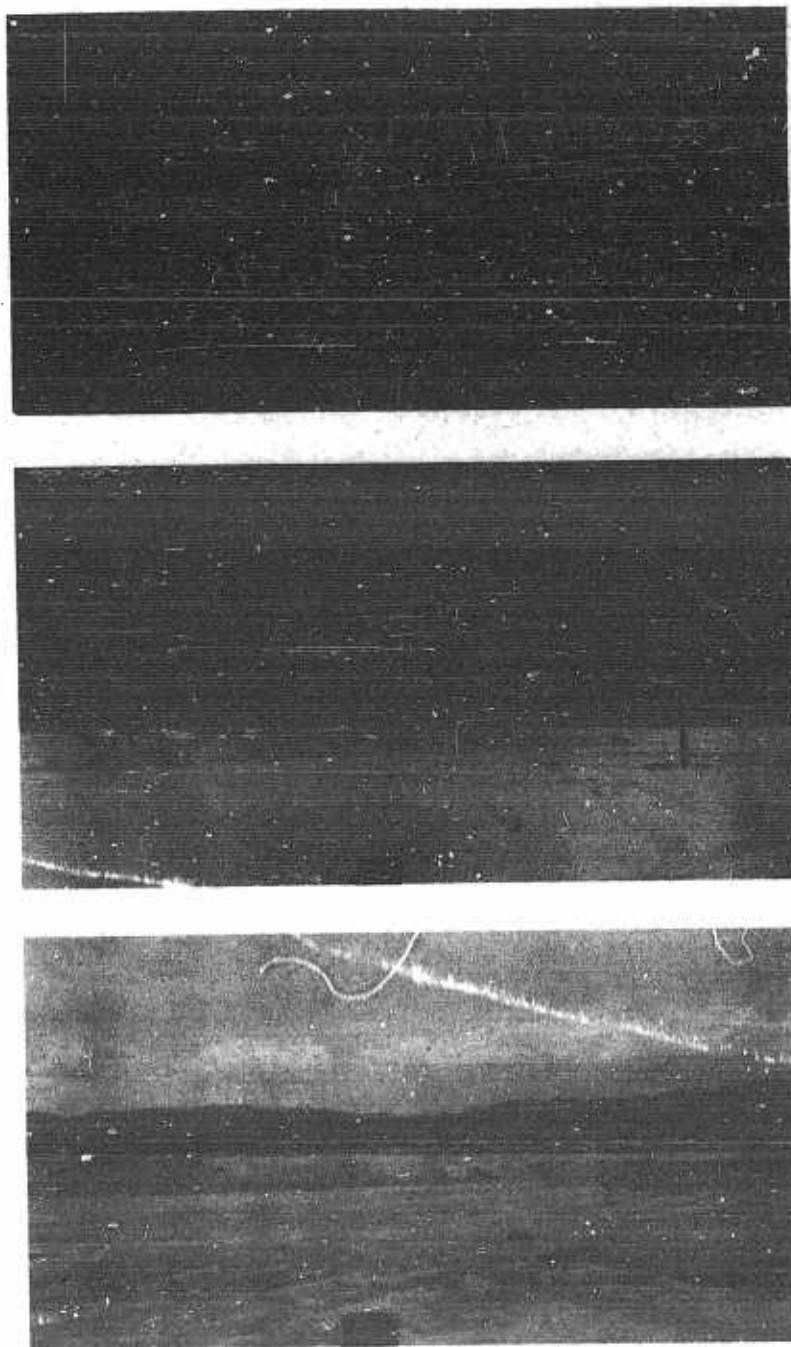
Fig. 3.60 Shots 9 and 10, Test Groups 6 and 6A, Separate Poles. (Top-before 9, Bottom-after 10) (In Bottom View the Splintered Stubs of the Three Poles can be Seen Diagonally Across the Photo from Right to Left) Shot 9 - 2825 ft, 61.5 cal, 10.8 psi. Shot 10 - 2125 ft, over 60 cal, 7 psi.

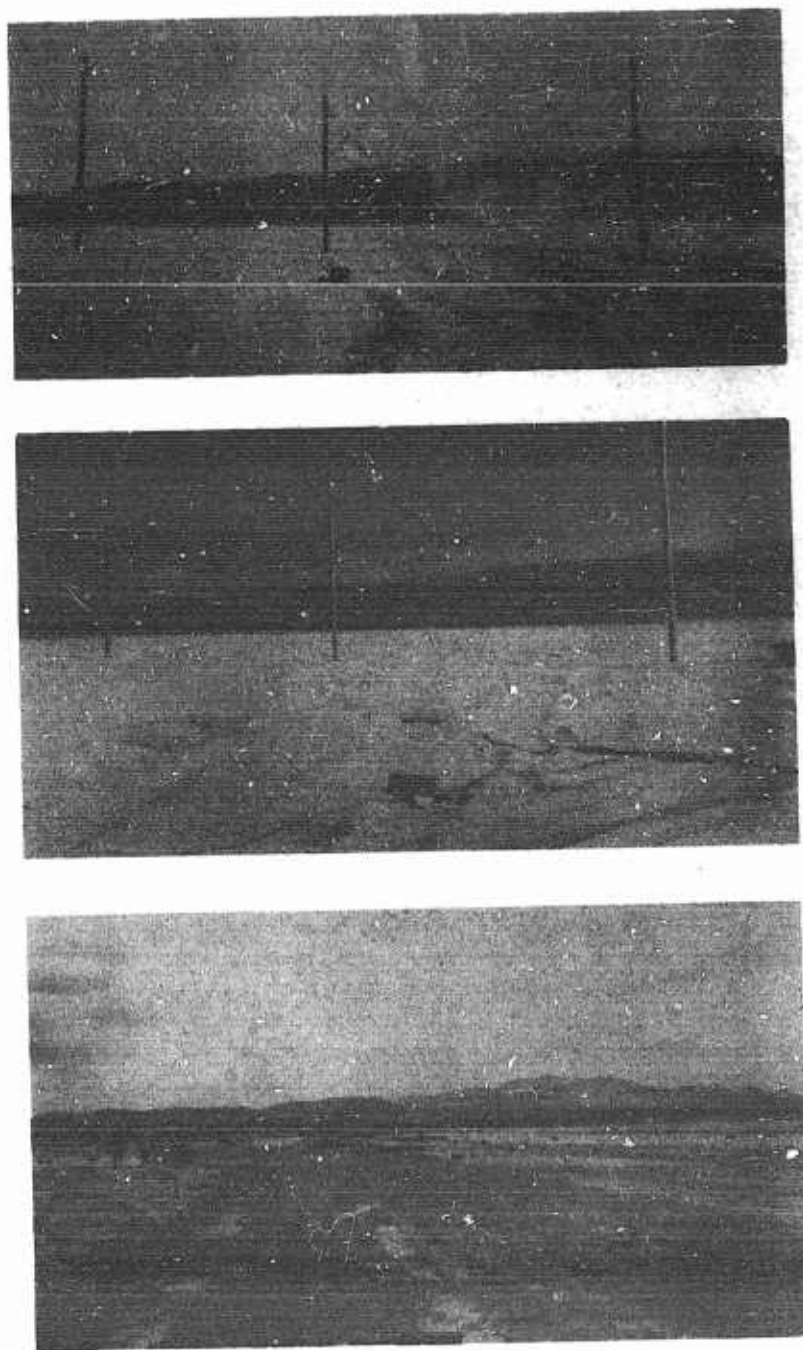
Fig. 3.61 Shots 9 and 10, Test Groups 7 and 7A, Separate Poles. (Top-before 9, Center-after 9, Bottom-after 10) (In Bottom View Test Group 7A, 3 Separate Poles can be seen to the Right of Pole D-36. Test Group 7A is the First of the Separate Poles which Remained Standing after Shot 10) Shot 9 - 3825 ft, 43.5 cal, 8.6 psi. Shot 10 - 3125 ft, 41 cal, 5 psi.

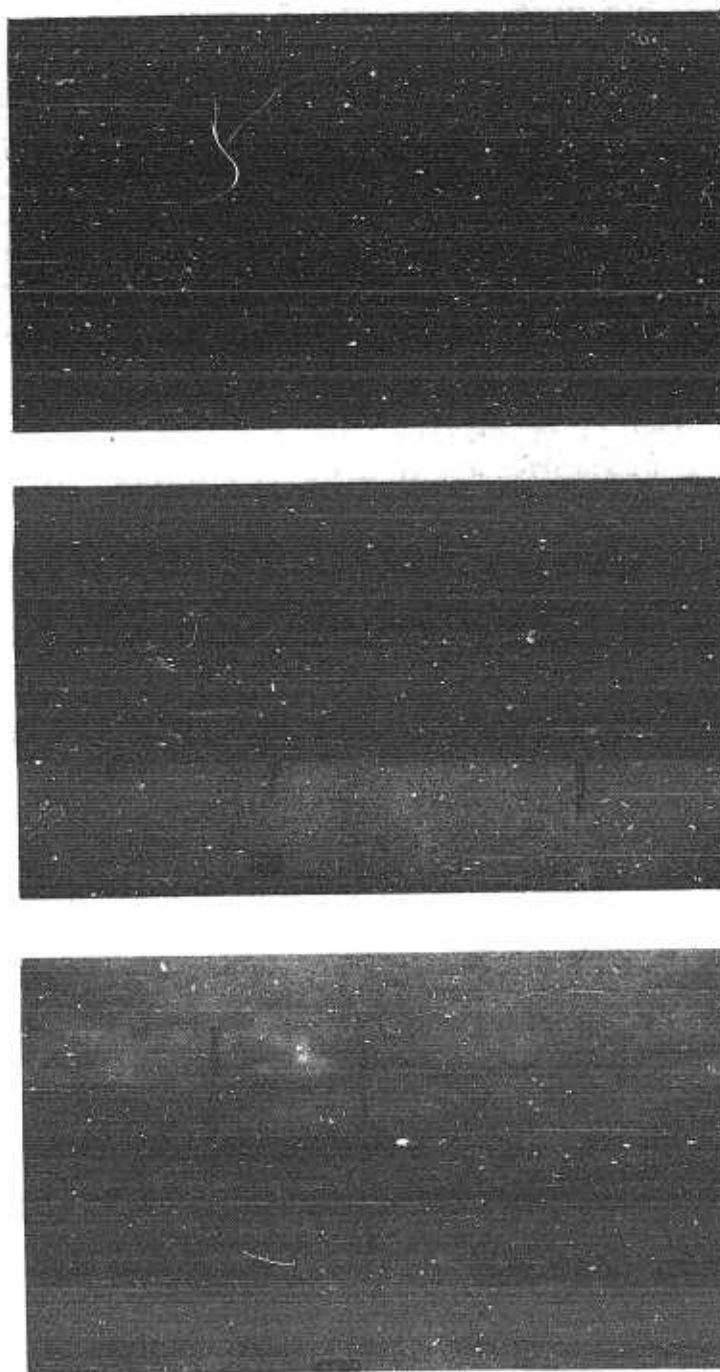
Fig. 3.62 Shots 9 and 10, Test Groups 8 and 8A, Separate Poles. (Top-before 9, Center-after 9, Bottom-after 10) (Pole on Bottom Right was Removed for other use prior to Shot 10.)
Shot 9 - 4875 ft, 30.5 cal, 6.2 psi.
Shot 10 - 4200 ft, 24 cal, 4 psi.

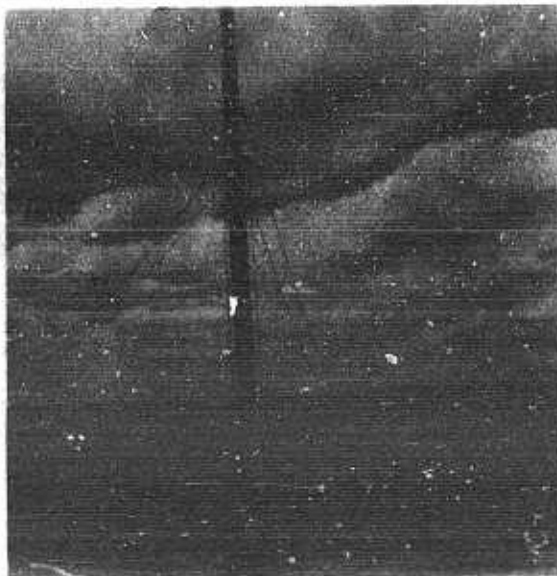
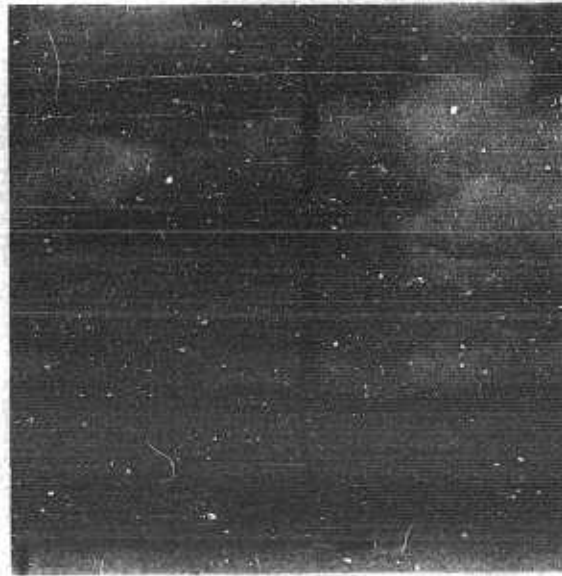
b. RESULTS: These poles received no significant damage in Shot 9.

Fig. 3.64 Shot 9, Test Group 83.
SigC Items in Med. C. Installations,
Separate Pole. (Top-before, Bottom-
after) 4125 ft, 39.5 cal, 8 psi.

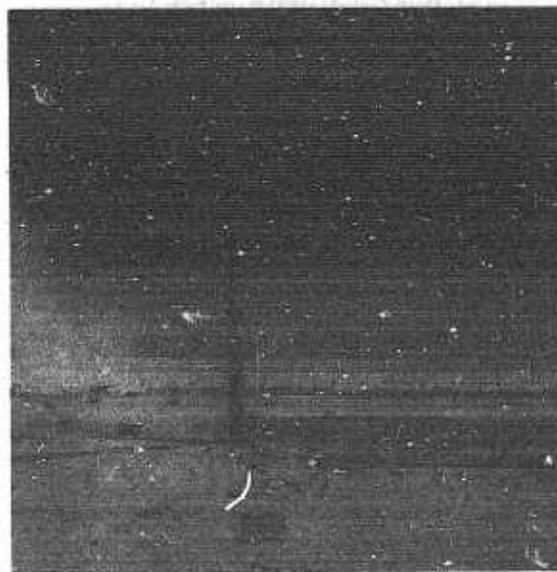
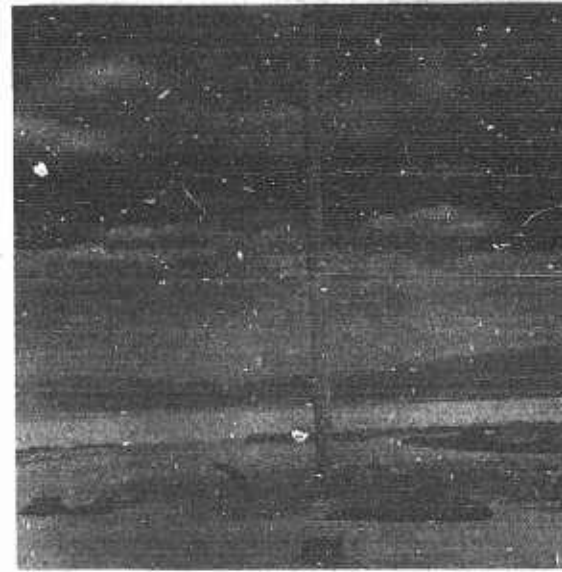
Fig. 3.65 Shot 9, Test Group 84.
SigC Items in Med.C. Installations,
Separate Pole (Top-before, Bottom-
after) 9000 ft, 8.5 cal, 3 psi.

NOTE: Wire and Attachments Removed from Pole after Shot 9 but Prior to
Taking the Bottom Photo. They were not damaged.

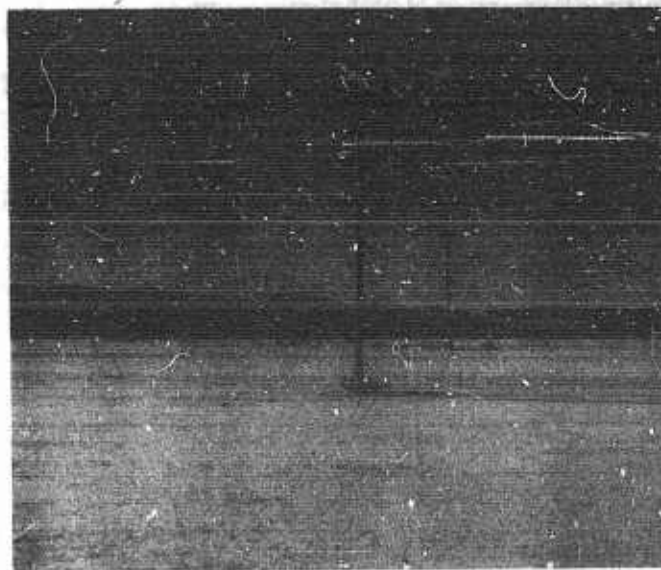
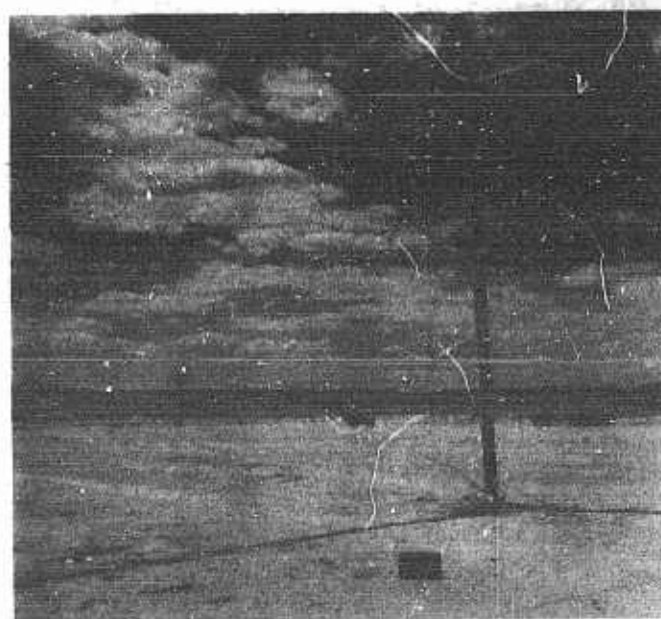
b. RESULTS: None of the separate poles received any significant damage in Shot 9. A damage summary of these test groups is shown in Table 3.9.

Fig. 3.67 Shots 9 and 10, Test Groups 103 and 103A, Separate Pole.
 (Top-before 9, Center-after 9, Bottom-after 10)
 Shot 9 - 1150 ft, 120 cal, 17.8 psi.
 Shot 10 - 500 ft, over 60 cal, over 115 psi.

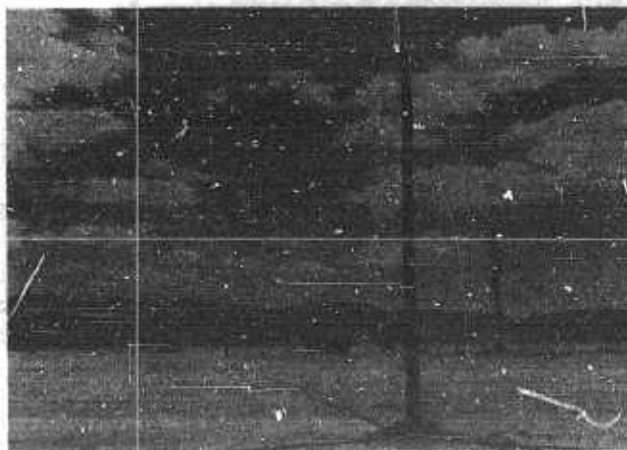
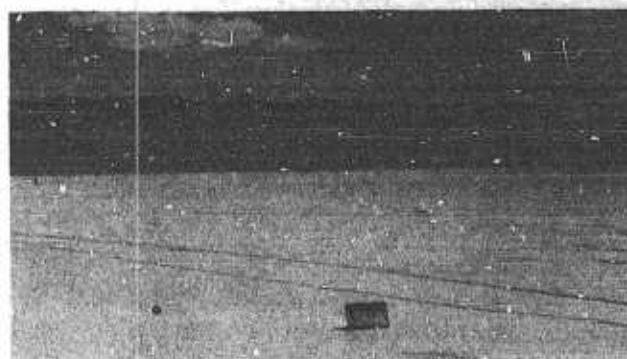
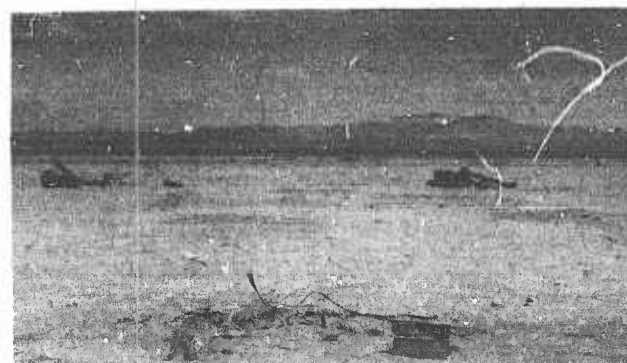
Fig. 3.68 Shots 9 and 10, Test Groups 104 and 104A, Separate Pole.
 (Top-before 9, Center-after 9, Bottom-after 10) (In
 Center View Test Group 104 is the First Pole from Left
 to Right in the Background. In Bottom View Test Group
 104A was 900 ft forward of Test Group 105A, about where
 the Pole Stub can be seen in Upper Righthand Side of
 Bottom Photo. Shot 9 - 850 ft, over 120 cal, over 21 psi.
 Shot 10 - 300 ft, over 60 cal, over 115 psi.

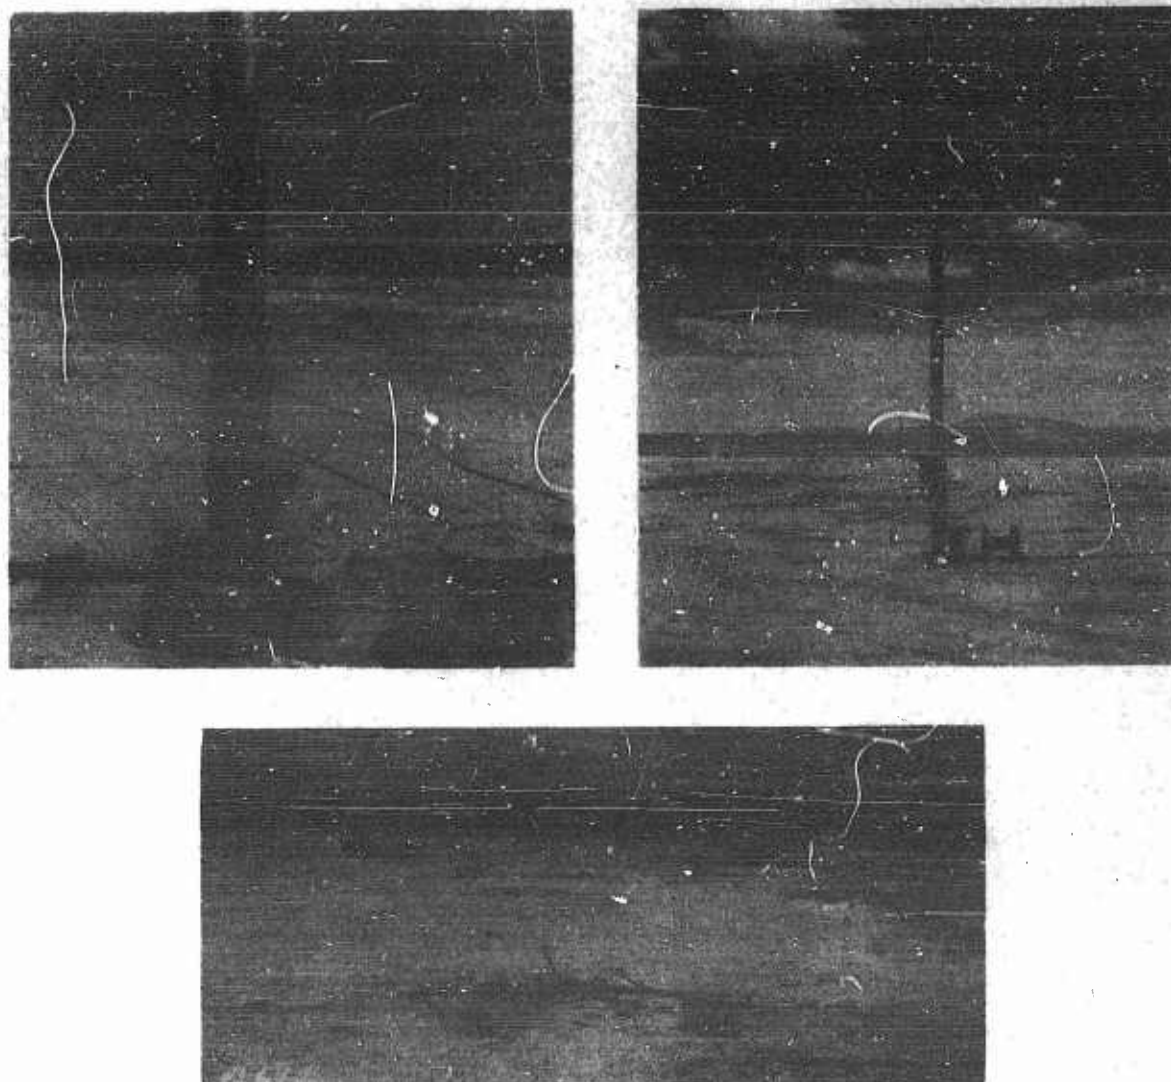
Fig. 3.69 Shots 9 and 10, Test Groups 105 and 105A, Separate Pole.
(Top-before 9, Right-after 9, Bottom-after 10)
Shot 9, 175 ft, over 120 cal, over 21 psi.
Shot 10 - 800 ft, over 60 cal, over 90 psi

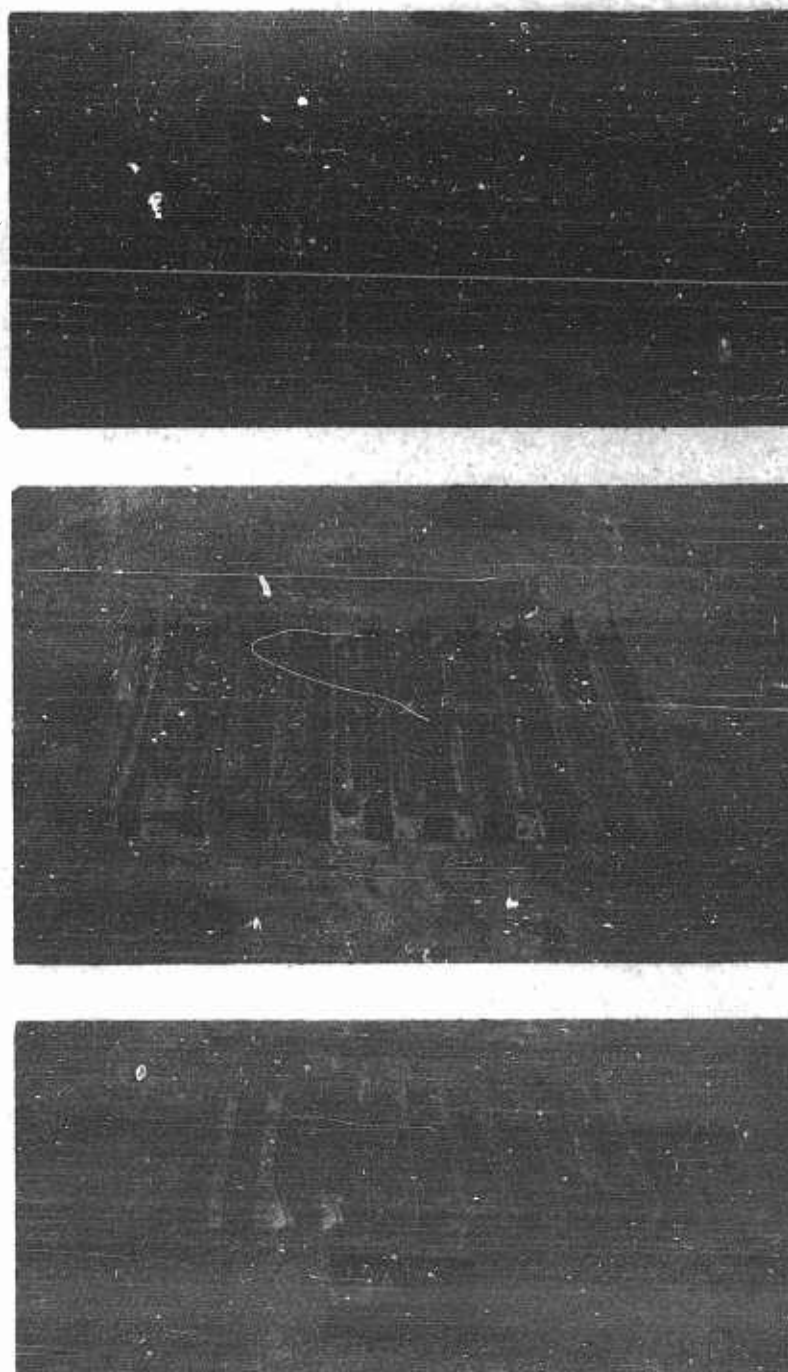
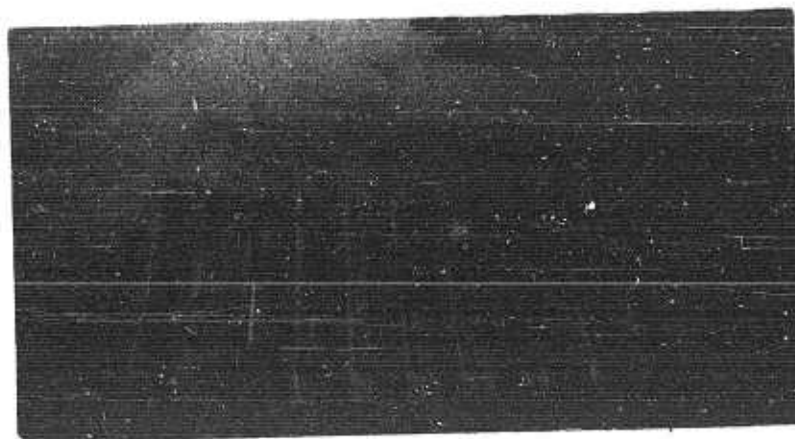
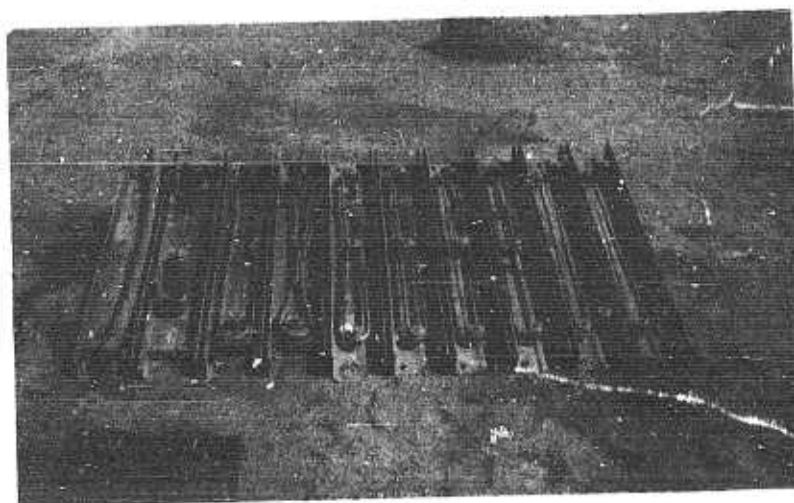
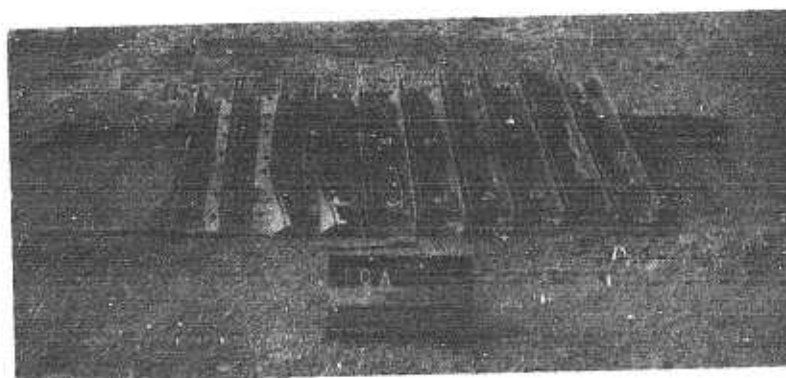
Fig. 3.70 Shots 9 and 10, Test Groups 10 and 10A, Exposure Boards.
(Top-before 9, Center-after 9, Bottom-after 10) (A new
Exposure Board was Positioned for Shot 10.) Shot 9 -
Shot 9 - 1825 ft, 88 cal, 13.2 psi.
Shot 10 - 1125 ft, over 60 cal, 32 psi.

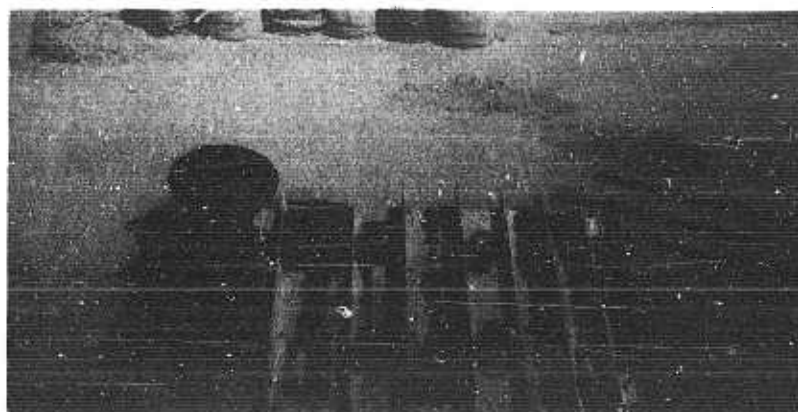
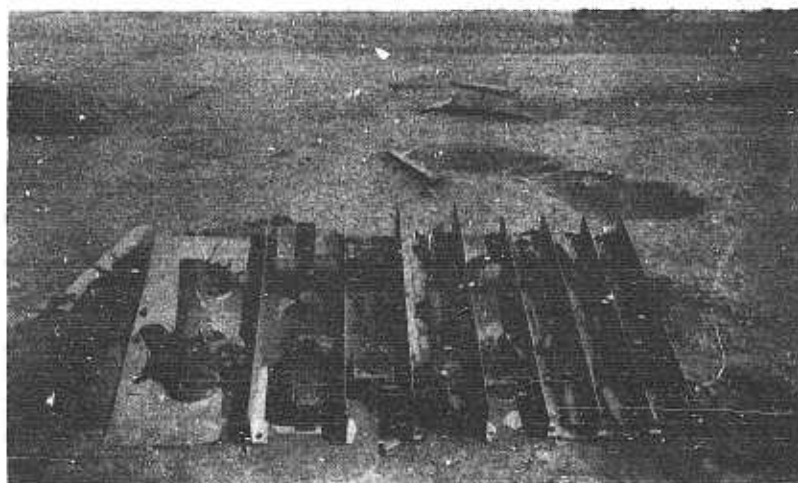
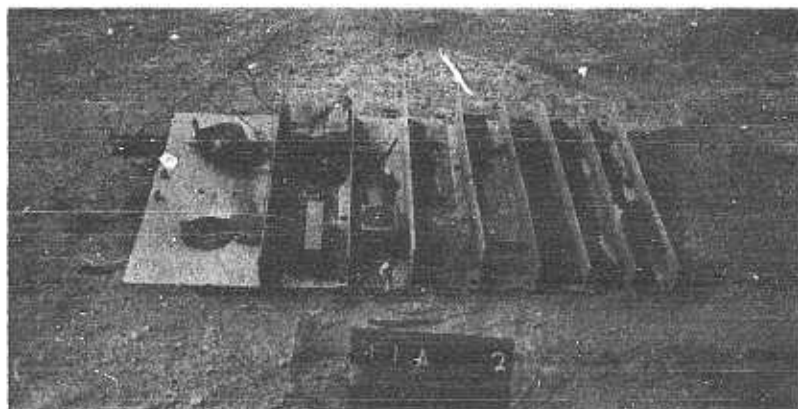
Fig. 3.71 Shots 9 and 10, Test Groups 11 and 11A, Exposure Boards, (Top-before 9, Center-after 9, Bottom-after 10) (A new Exposure Board was Positioned for Shot 10.) Shot 9 - 1825 ft 88 cal, 13.2 psi. Shot 10 - 1125 ft, over 60 cal, 32 psi.

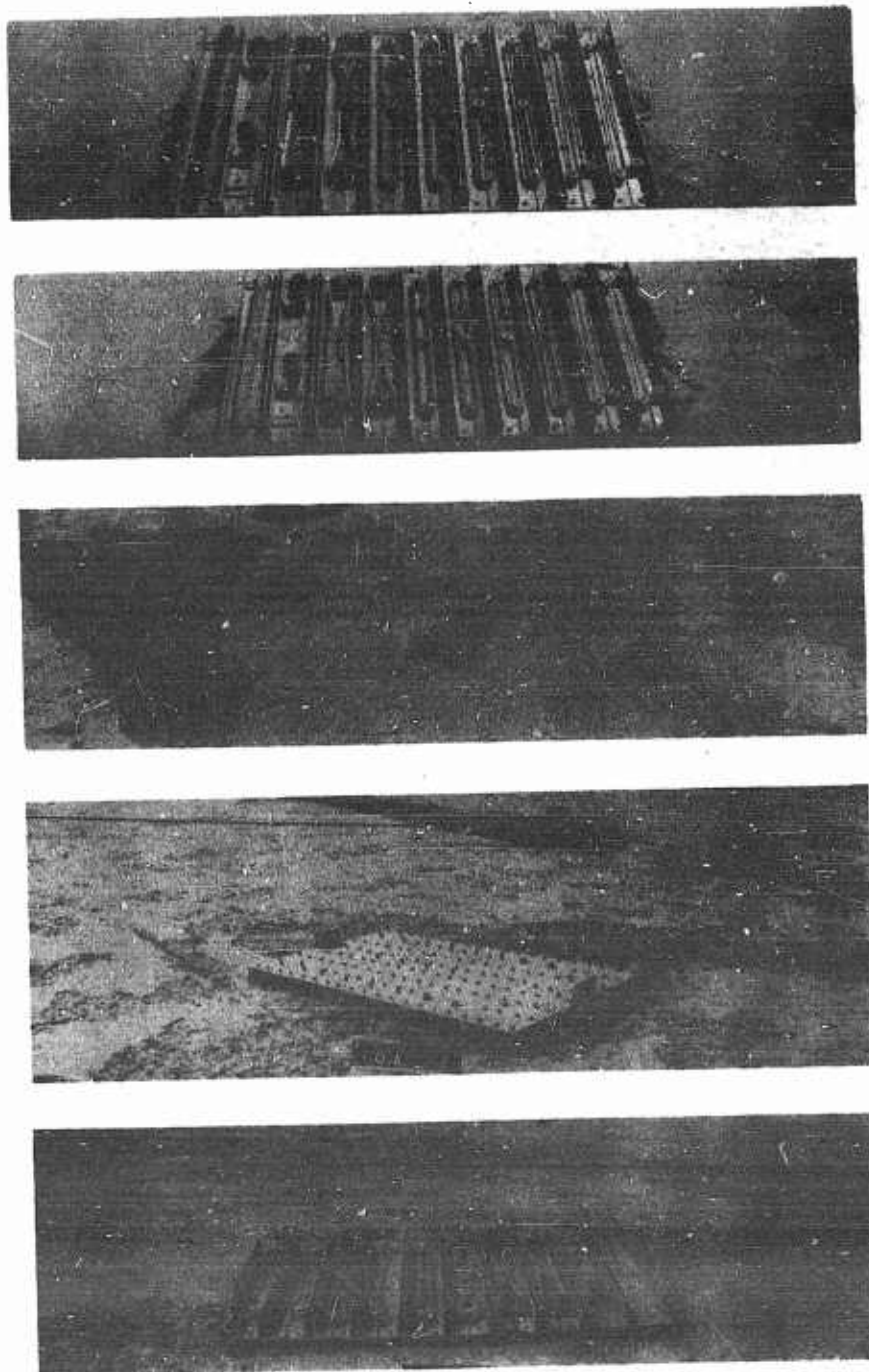
Fig. 3.72 Shots 9 and 10, Test Groups 12 and 12A, Exposure Boards.
 (Top-before 9, Second-after 9, Third-after 10, Fourth-
 Position of Board 12A, 450 ft from Original Position,
 Bottom-Appearance of Board after it was Turned Over.)
 Shot 9 - 2800 ft, 62 cal, 10.8 psi. Shot 10 - 2125 ft,
 over 60 cal, 7 psi.

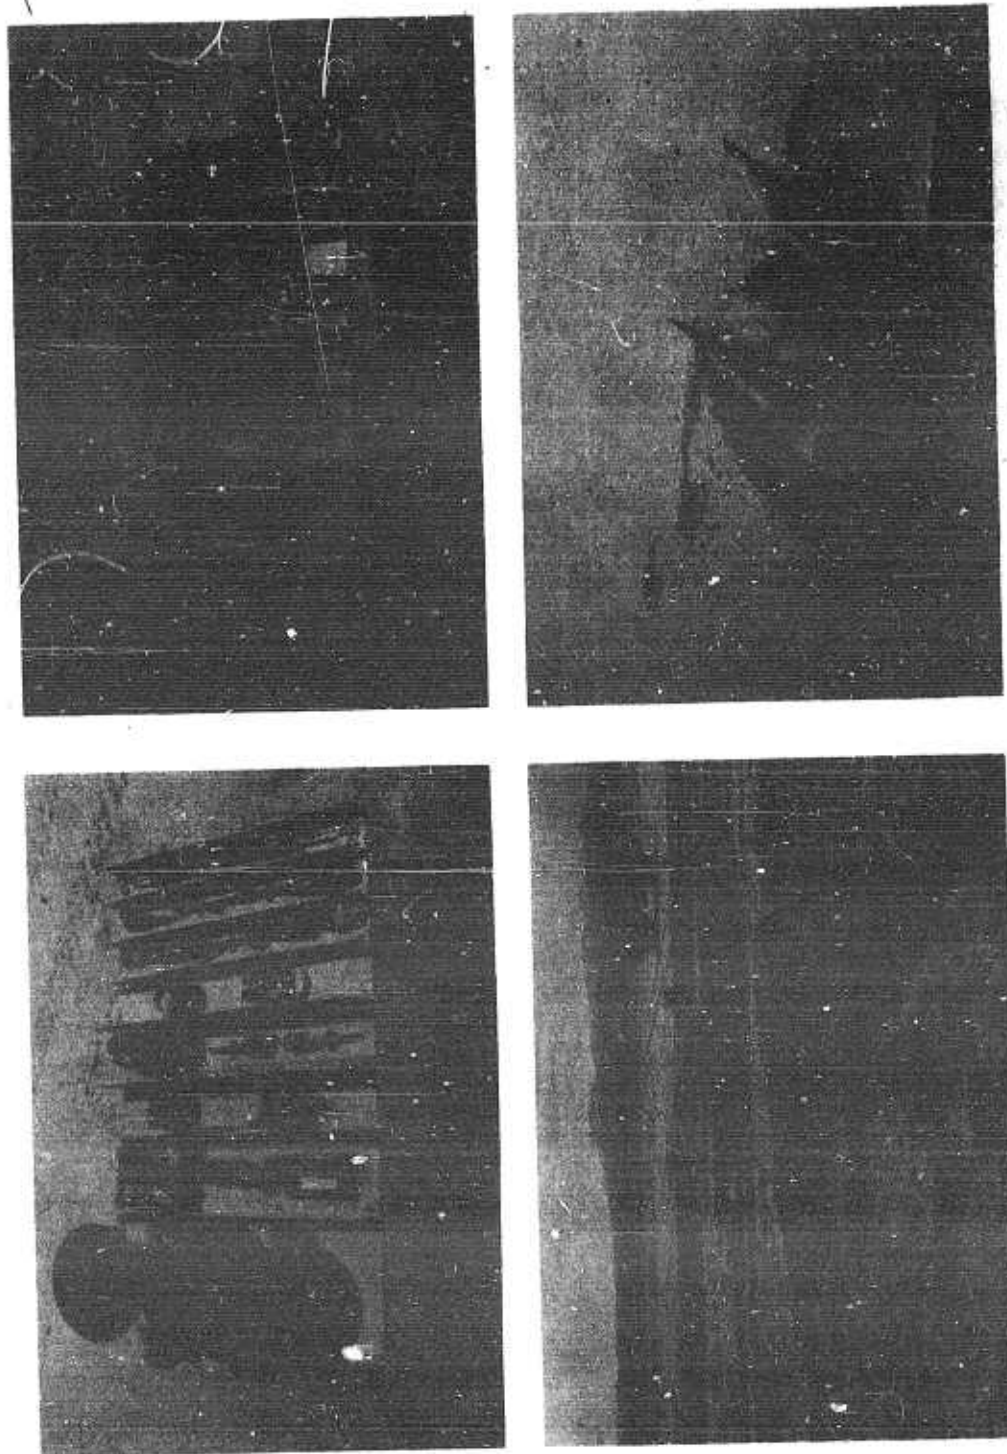
Fig. 3.73 Shots 9 and 10, Test Groups 13 and 13A, Exposure Boards. (Top left-before 9, Top right-after 9, Bottom-after 10) A New Exposure Board was Positioned for Shot 10. Bottom right-landing Position of Board 13A, 450 ft from Original Position in Shot 10. Shot 9 - 2800 ft, 62 cal, 10.8 psi. Shot 10 - 2125 ft, over 60 cal, 7 psi.

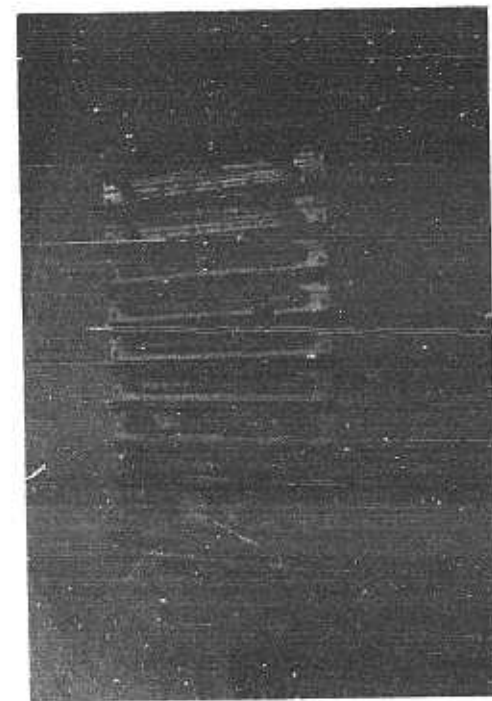
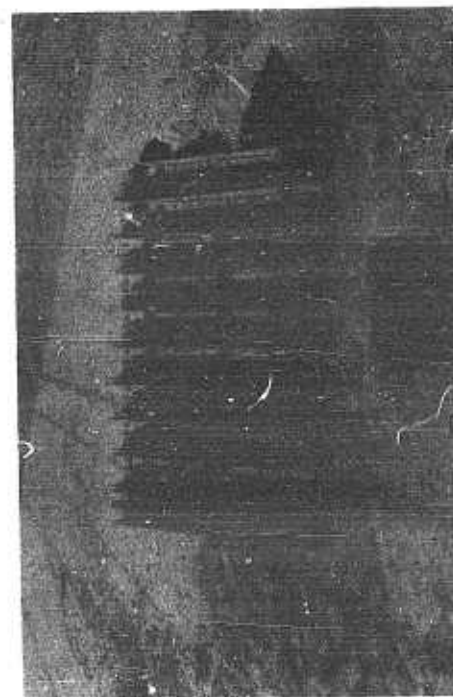
Fig. 3.74 Shot 9, Test Group 14, Exposure Boards.
(Top left-before, Bottom left-after)
3825 ft, 43.5 cal. 8.6 psi.

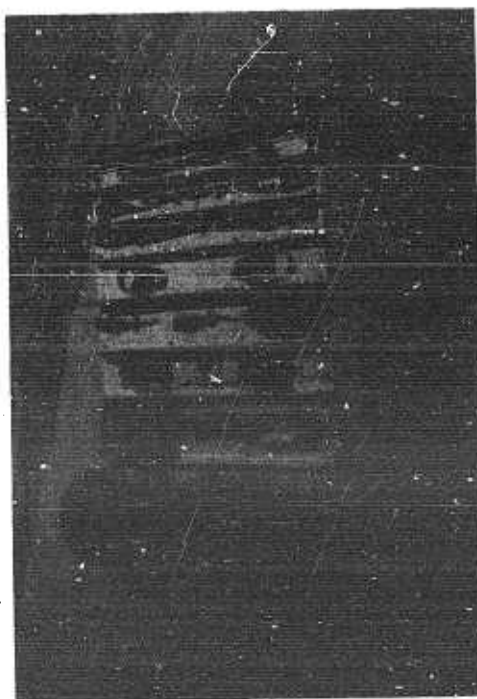
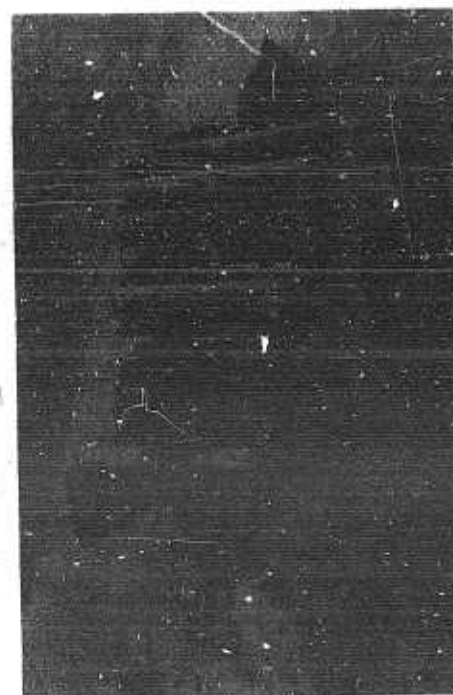
Fig. 3.75 Shot 9, Test Group 15, Exposure Board.
(Top right-before, Bottom right-after)
3825 ft, 43.5 cal, 8.6 psi.

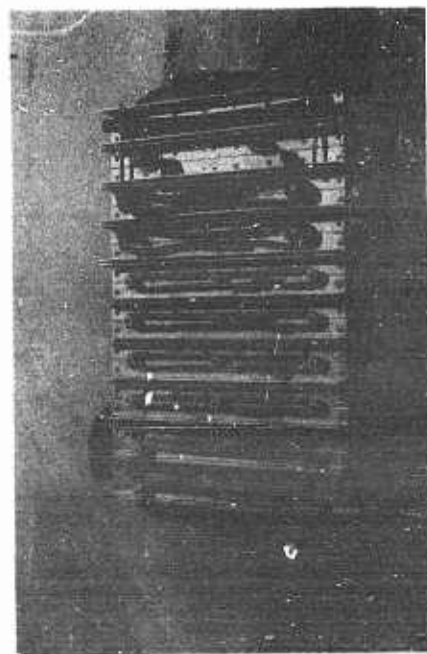
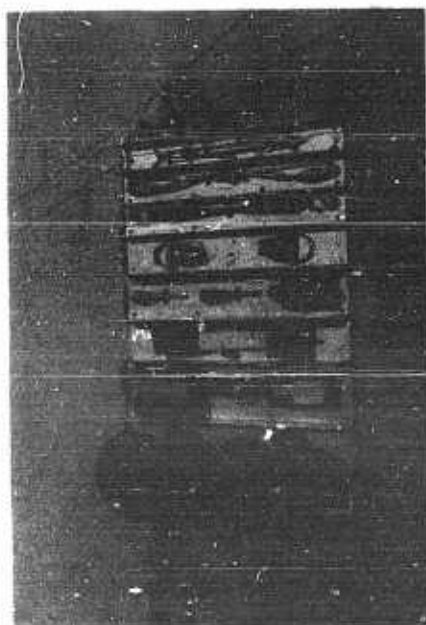
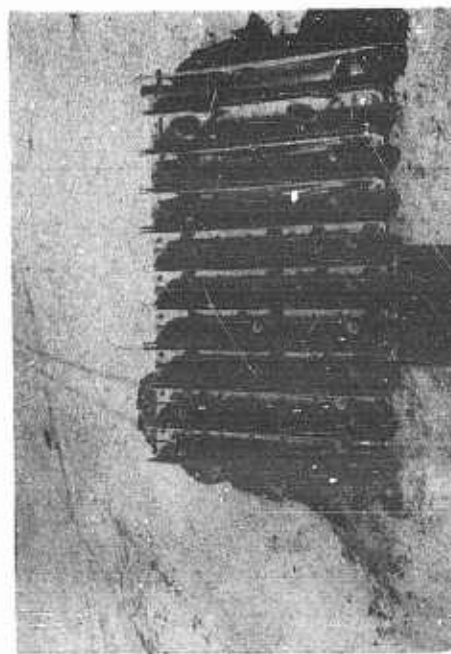
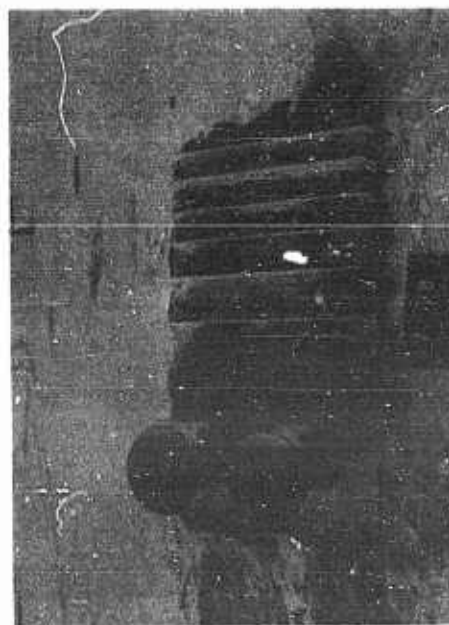
Fig. 3.76 Shot 9, Test Group 16, Exposure Board.
(Top-before, Bottom-after) NOTE: The
Positions of the Test Items on this
Exposure Board were Inadvertently
Reversed from Those of Other Exposure
Boards. 4800 ft, 30.5 cal, 6.4 psi.

Fig. 3.77 Shot 9, Test Group 17, Exposure Board.
(Top-before, Bottom-after)
4800 ft, 30.5 cal, 6.4 psi.

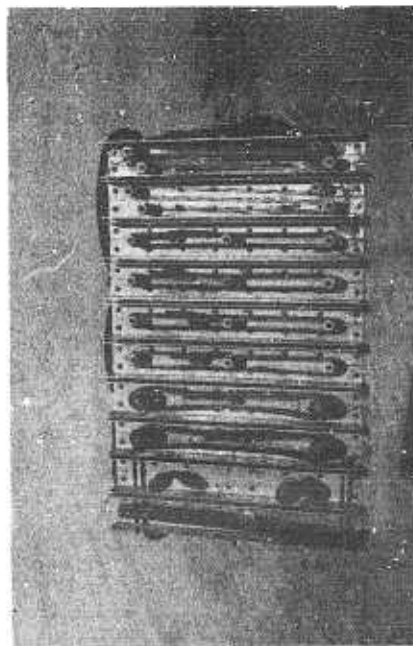
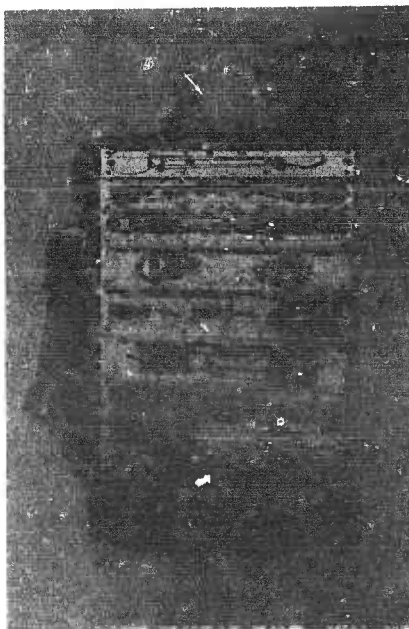
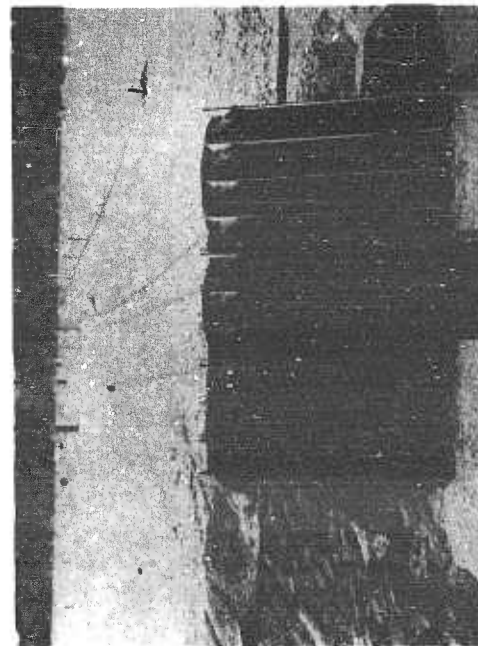
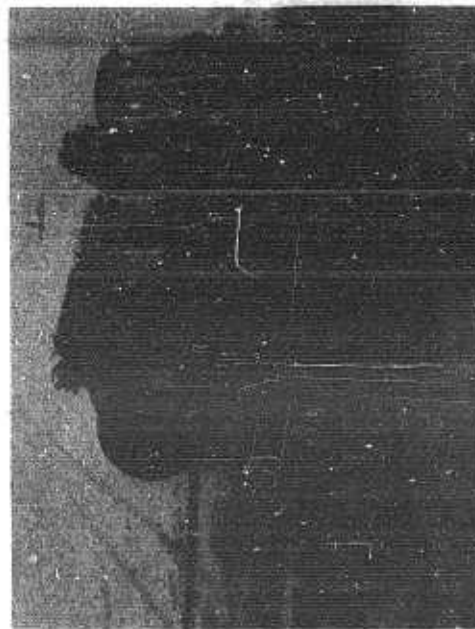
Fig. 3.78 Shot 9, Test Group 18, Exposure Board.
(Top-before, Bottom-after)
5800 ft, 23.5 cal, 7.2 psi.

Fig. 3.79 Shot 9, Test Group 19, Exposure Board.
(Top-before, Bottom-after)
5800 ft, 23.5 cal, 7.2 psi.

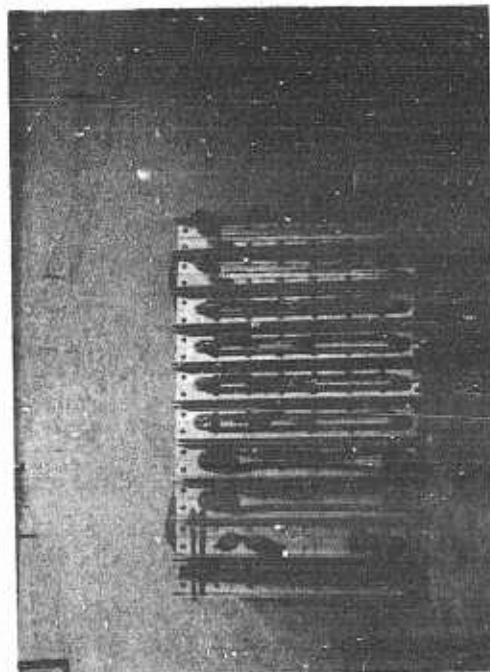
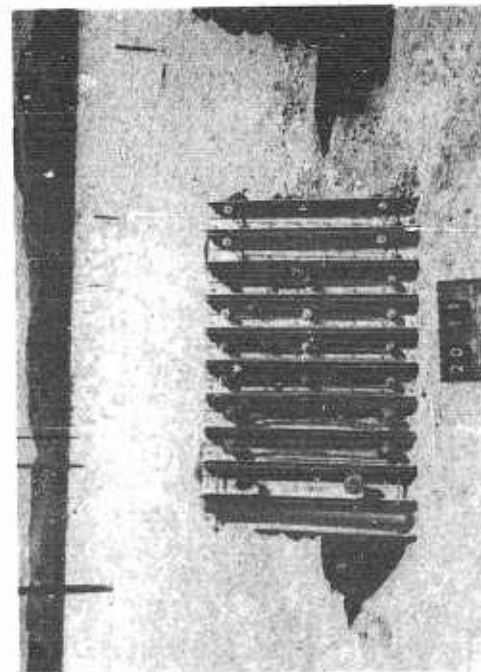
Fig. 3.80 Shot 9, Test Group 20, Exposure Board.
(Top-before, Bottom-after)
6800 ft, 16.5 cal, 4.2 psi.
